Information Sheet T011: BioTector 970/990 Trouble Shooting.

BioTector 970/990 Trouble Shooting: if the BioTector does not produce any TIC or TOC CO₂ peaks.

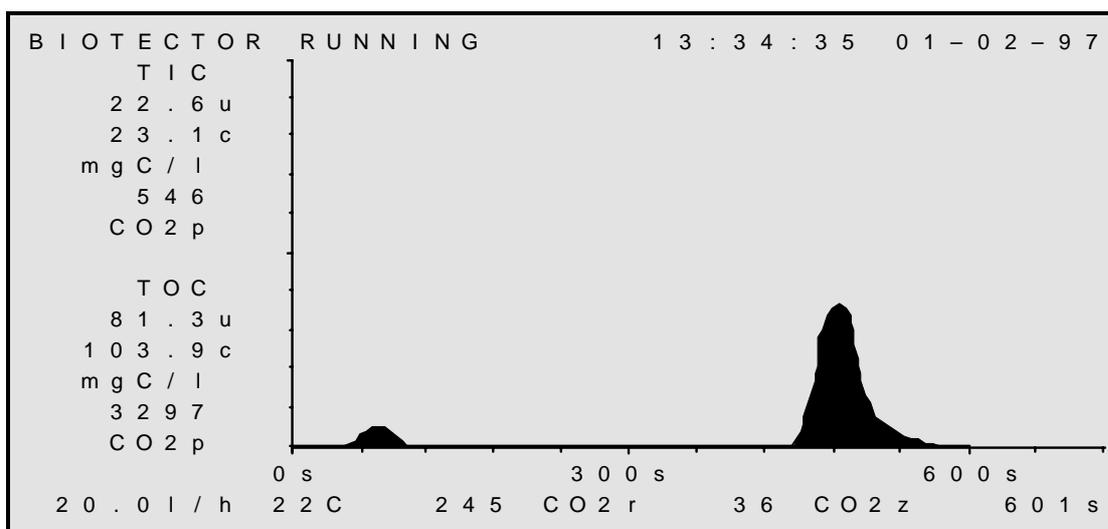
REACTION GRAPH SCREEN

The following shows a typical BioTector reaction graph screen.

After having carried out all the tests detailed on the previous pages, should the BioTector fail to perform correctly, please draw a sketch of the reaction graph that it displays on the blank reaction graph screens provided in the following pages. Fill in as much information as possible in the blank spaces, give the location /serial number of the BioTector and fax back to BioTector Analytical Systems Limited
